# Manhole Inspection Summary

Manhole # S29A\_\_053MH

Insp Date: **3/12/08 2:02 PM**

**Location** Address: **INT.MARTIN LUTHER KING BLVD** Cross Street: **PENNSYLVANIA AVE**

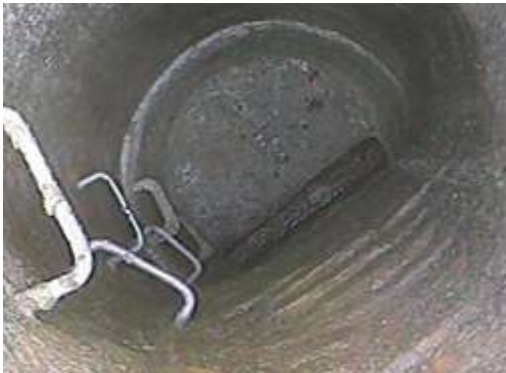
Top View

**Surcharge** ☒ **Evidence Of Surcharge** Depth: **4** (ft.) ☐ Active Surcharge Present

EVIDENCE OF SURCHARGE

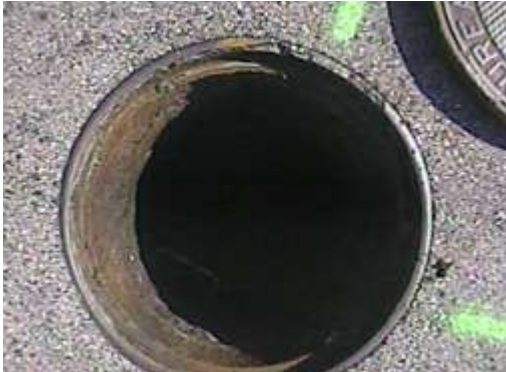
Defect 1

**Frame** Offset: **0** (in.) Condition: ☐ Sound ☒ **Cracked** ☐ Leaks

CRACKED FRAME

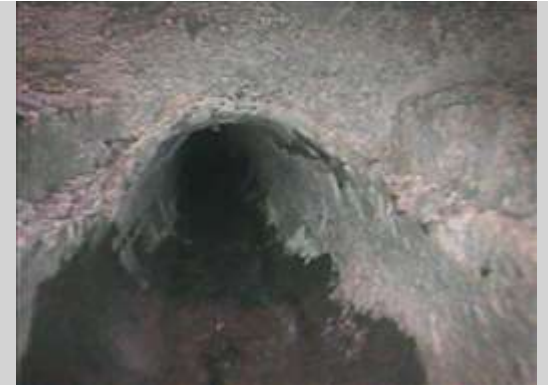
12 O'Clock Outflow

8 in. Circular Gravity Sewer  
Pipe Out @ 12 O'Clock

Invert Depth: **12.38** (ft.) Flow Characteristics: **Slow**

Infiltration: **None** Pipe Seal Cond: **Sound**

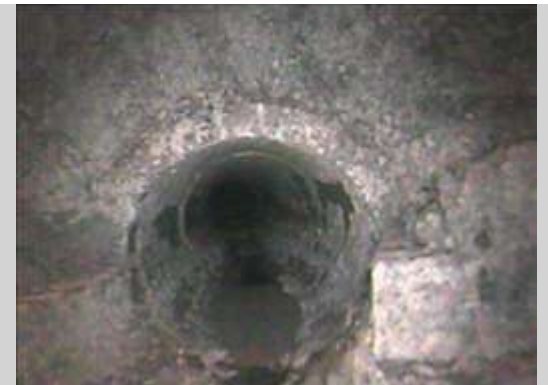
3 O'Clock Inflow

6 in. Circular Gravity Sewer  
Pipe In @ 3 O'Clock

Invert Depth: **9.34** (ft.) Flow Characteristics: **Slow**

Infiltration: **None** Pipe Seal Cond: **Sound**

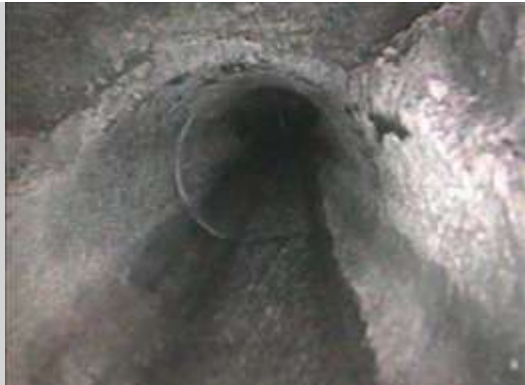
6 O'Clock Inflow

8 in. Circular Gravity Sewer

Pipe In @ 6 O'Clock

Invert Depth: **12.31** (ft.) Flow Characteristics: **Slow**

Infiltration: **None** Pipe Seal Cond: **Sound**
